**Report: Chilt/RF09105**

**A fire resistance test performed on two single leaf single acting doorsets with glazing**

**Test conducted in accordance with BSEN 1634-1: 2000 and BSEN 1363-1: 1999**

**Prepared for: Pacific Rim Wood Ltd  
Studio 3, Kingdom Fields  
Bratton Fleming  
Barnstaple  
EX21 4EN**

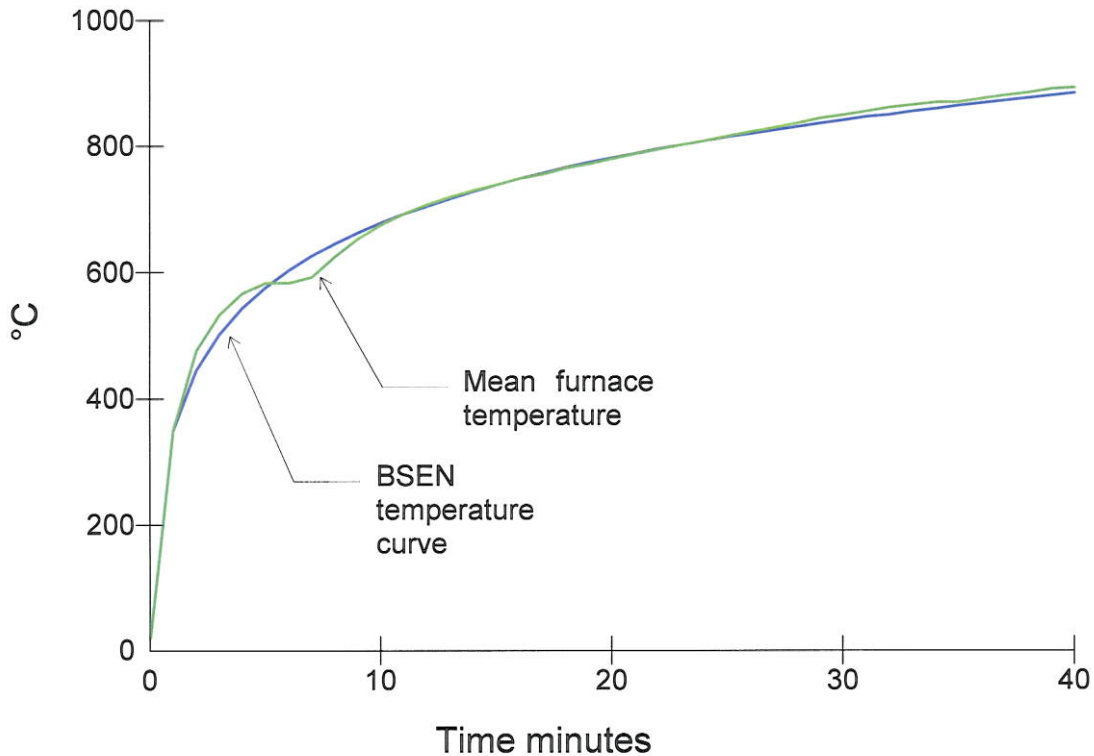
The furnace was controlled to follow the temperature/time relationship specified in BSEN 1363: Part 1: 1999 Section 5.1.1 as closely as possible, using the average of six plate thermocouples suitably distributed within the furnace. The temperatures recorded have been tabulated in Appendix 2 and are shown graphically below:

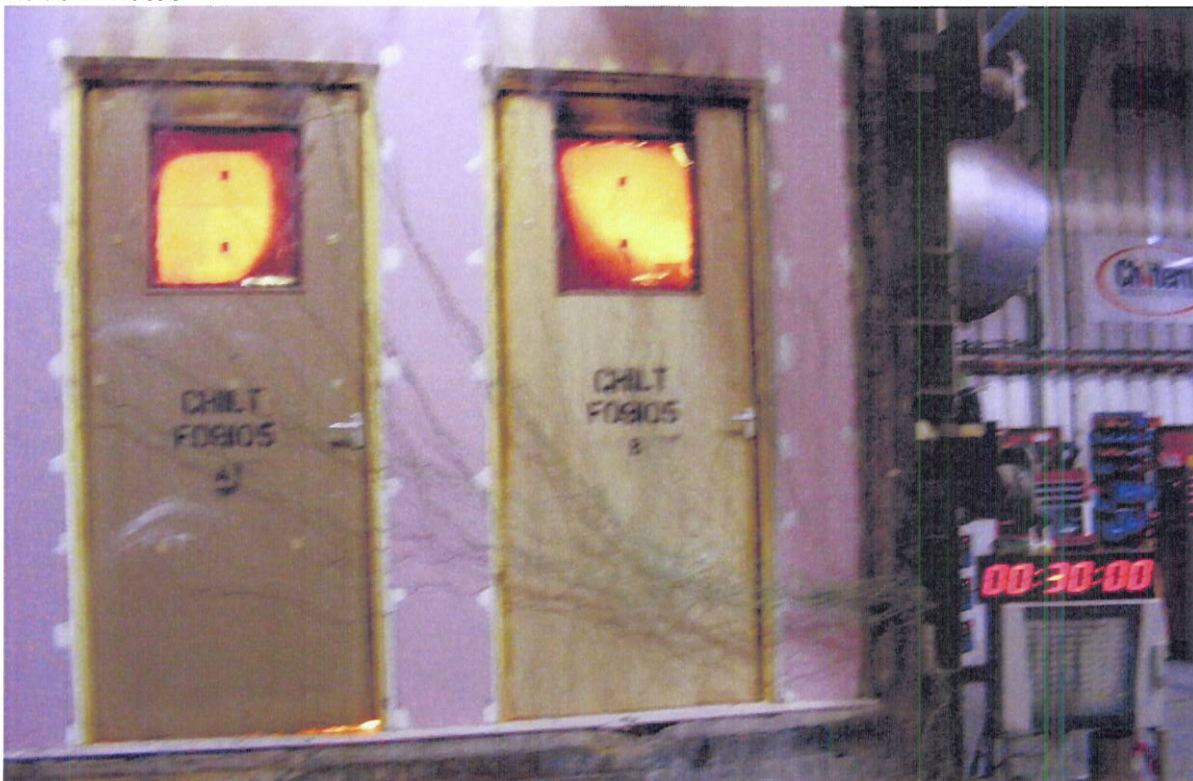
At 30 minutes

30.25	Doorset A, there is intermittent flaming at the left and right hand side bottom corners of the door.
31.30	Doorset A, a cotton pad integrity test was performed at the bottom right hand side of the door, no failure.
