The fire resistance performance of a single-leaf, single-acting doorset with glazing when tested in accordance with BS 476: Parts 20 and 22: 1987

408272 AR1

Pacific Rim Wood Ltd

20th December 2018

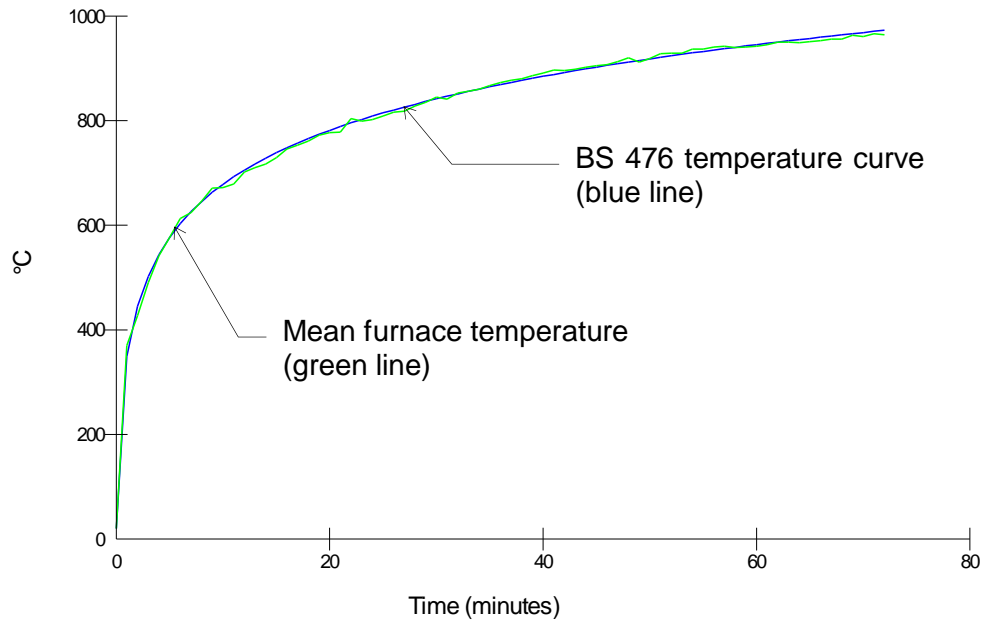
5.1 Furnace Temperature Curve

The furnace was controlled to follow the temperature/time relationship specified in BS 476: Part 20: 1987 as closely as possible, using the average of nine thermocouples suitably distributed within the furnace. The temperatures recorded are shown graphically in Section 5.1.

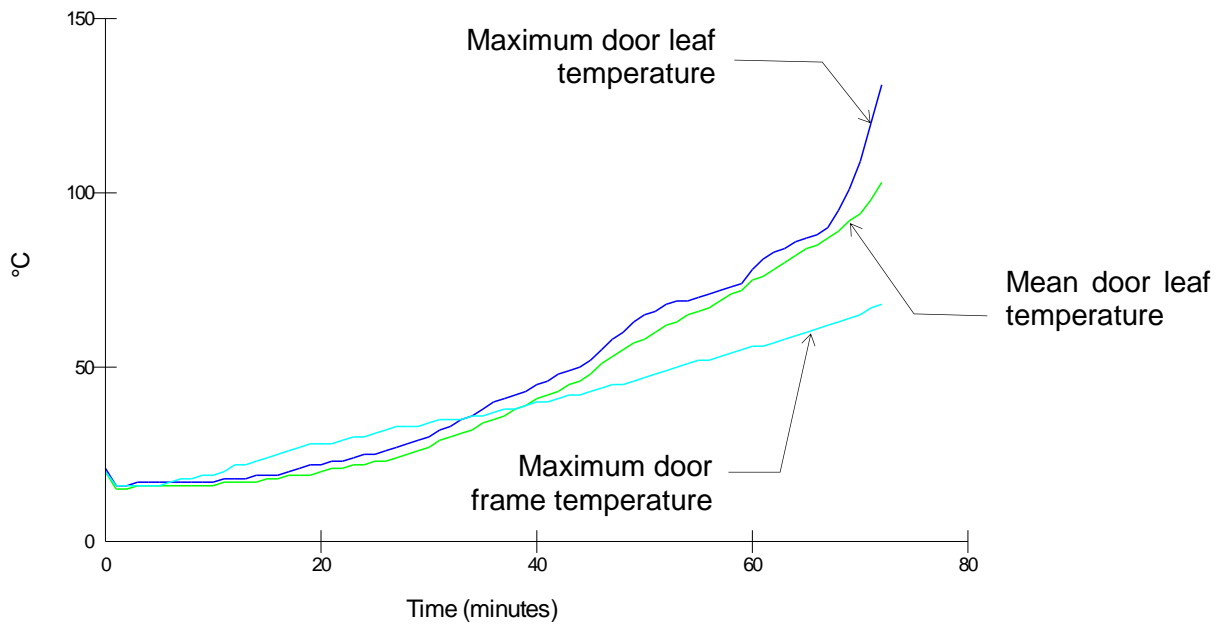
5.2 Unexposed Face Temperature Curves

The temperature of the unexposed face of was monitored by means of five thermocouples fixed to the surface of the door leaf and three thermocouples attached to the doorframe, one at mid height on each jamb and one centrally located on the frame head. Four additional thermocouples fixed to the glass.

The thermocouple positions are shown in Figure 4 of the appendix. The average temperature of the door leaf and maximum temperature of the doorset are shown graphically in Section 5.2.

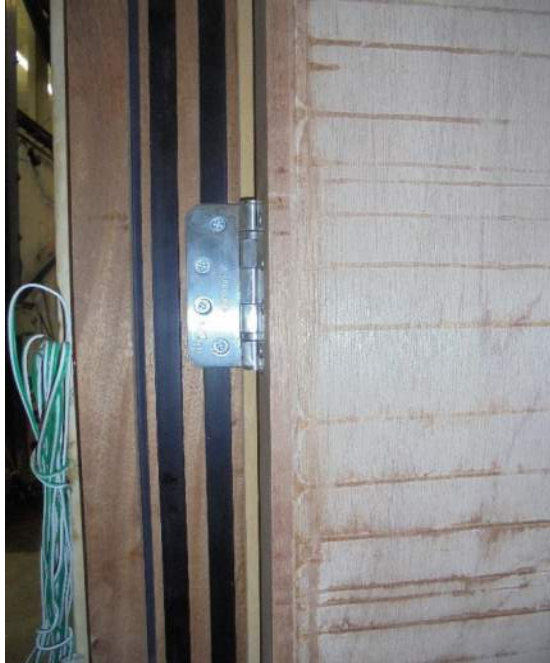
Around hinge blades

Make/type	Size (mm)	Location
Around hinge blade	Partially interrupted	-	Hinge blade fully interrupts 1 st seal leaving 2 nd seal continuous in frame reveal
Under hinge blades	Sealed Tight Solutions Ltd. Graphite*	1 thick	Fitted under the hinge blade on frame and leaf
Encasing the middle latch body	Sealed Tight Solutions Ltd. Solutions ST60 kit*	1 thick	Fitted to the cheeks of the centre latch body
Encasing top and bottom hook latch bodies	Sealed Tight Solutions Ltd. Solutions graphite*	110 x 30 x 1 thick	Fitted to both faces of the hook latch cases
Under lock drive strip in Eurogroove	Sealed Tight Solutions Ltd. ST10x2 Graphite*	10 x 2 thick	Fitted lining the full length of the Euro groove
Around latch keeps	Partially interrupted	-	The latch keep fully interrupt the 1 st seal leaving 11mm remaining of the 2 nd
Under latch keeps	Sealed Tight Solutions Ltd. Graphite*	20 x 1 thick	Fitted around the perimeter and under the latch keep forends

Intumescent interruption by hardware and additional intumescent protection

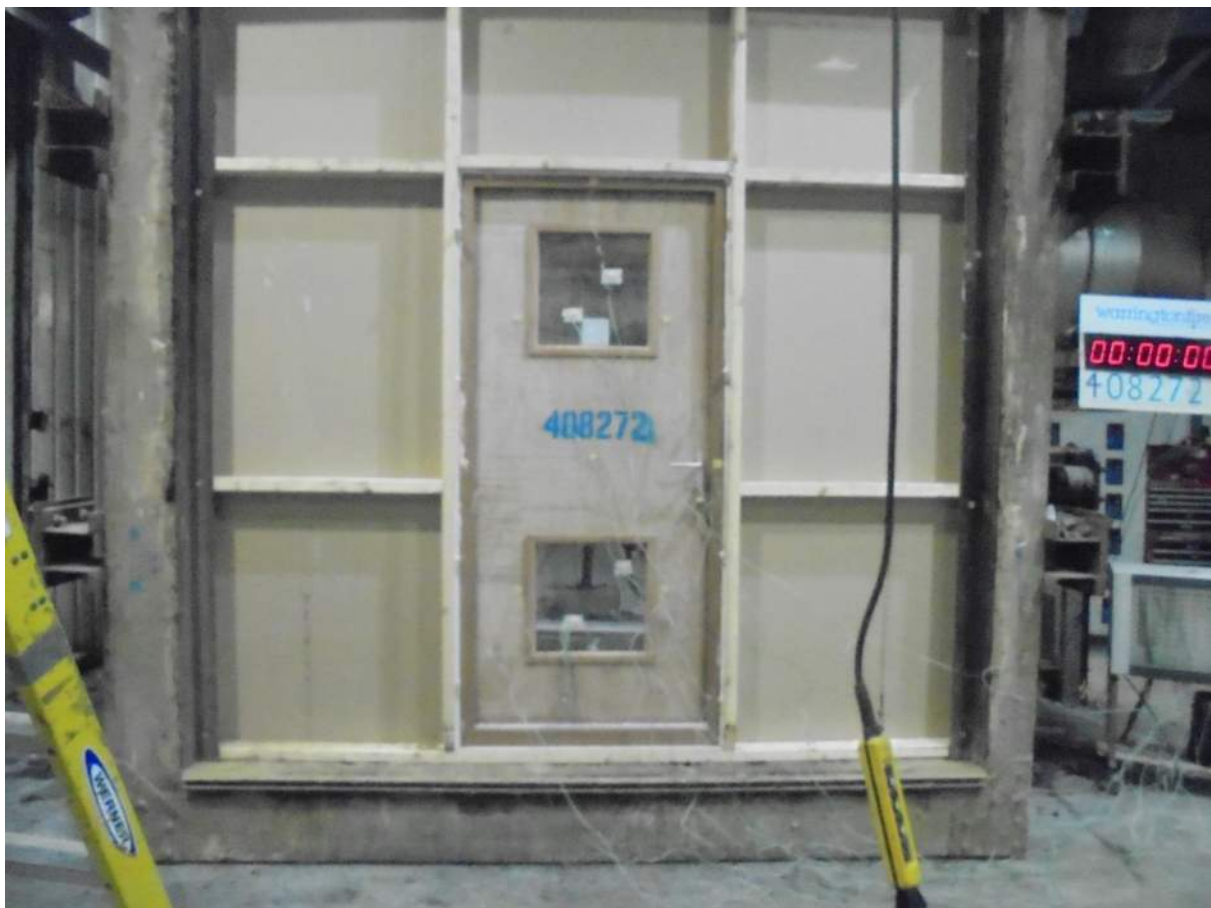
Prior to the start of the test

Summary of specimens: A latched single-leaf, single-acting doorset with glazing, hung opening in towards the furnace. Leaf size : 2040mm high x 928mm wide x 54mm thick
---	--

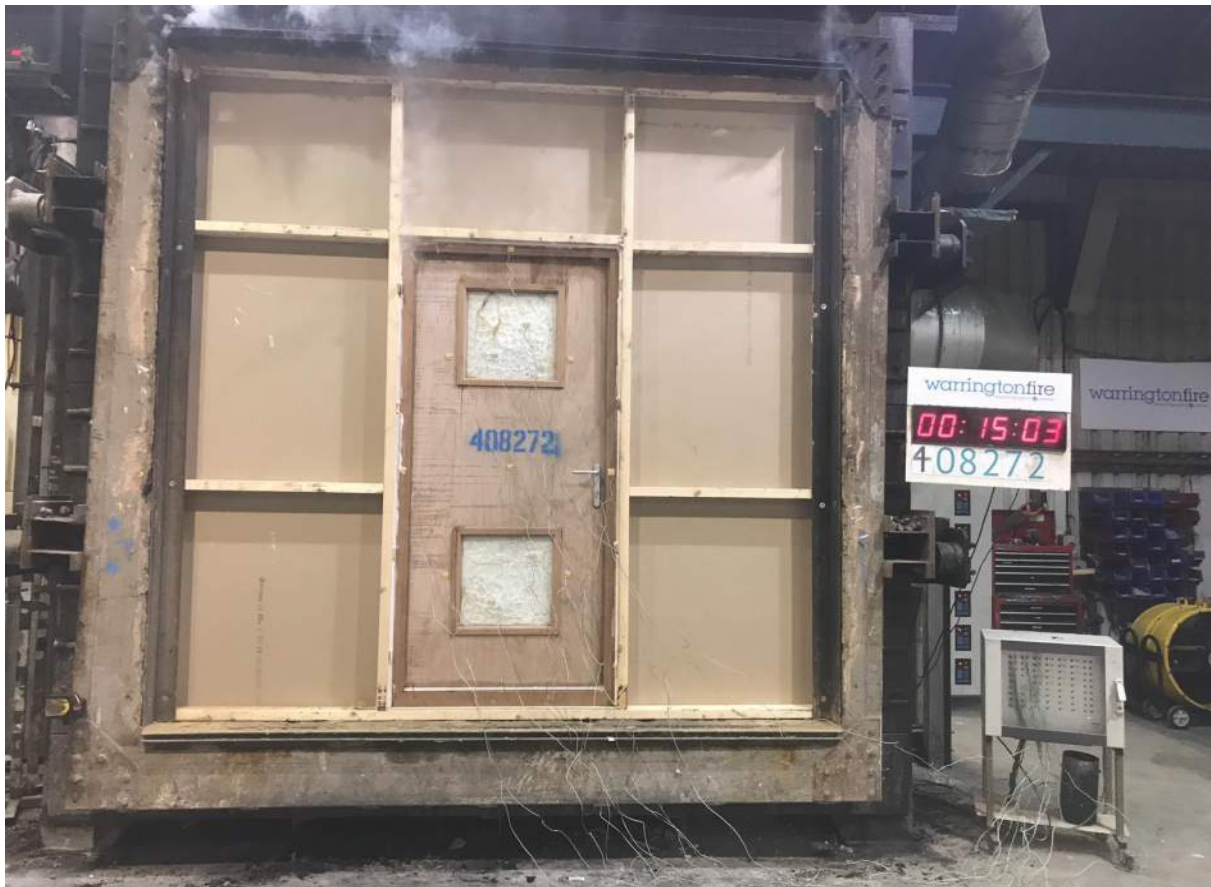
After 15 minutes

15:40	The top glazing bead is pulling away at the top right corner.
16:30	There is discolouration at the top left corner and the top right corner of the bottom glazing bead.

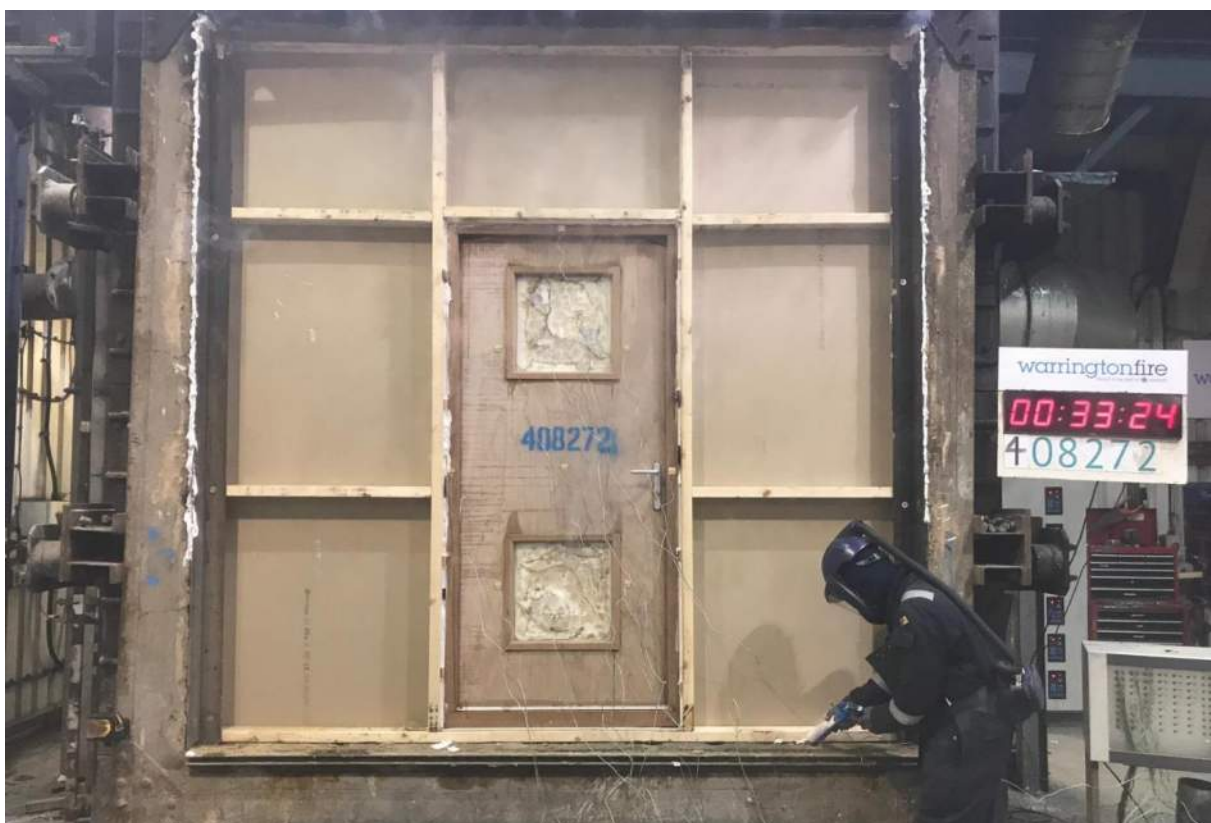
After 33 minutes

25:00	The mastic in the fire stopping gap is melting.
32:00	There is an increase in smoke issuing from the cracks in the glazing.
34:00	The seal is falling from the frame head at the top hanging corner and the top closing corner.

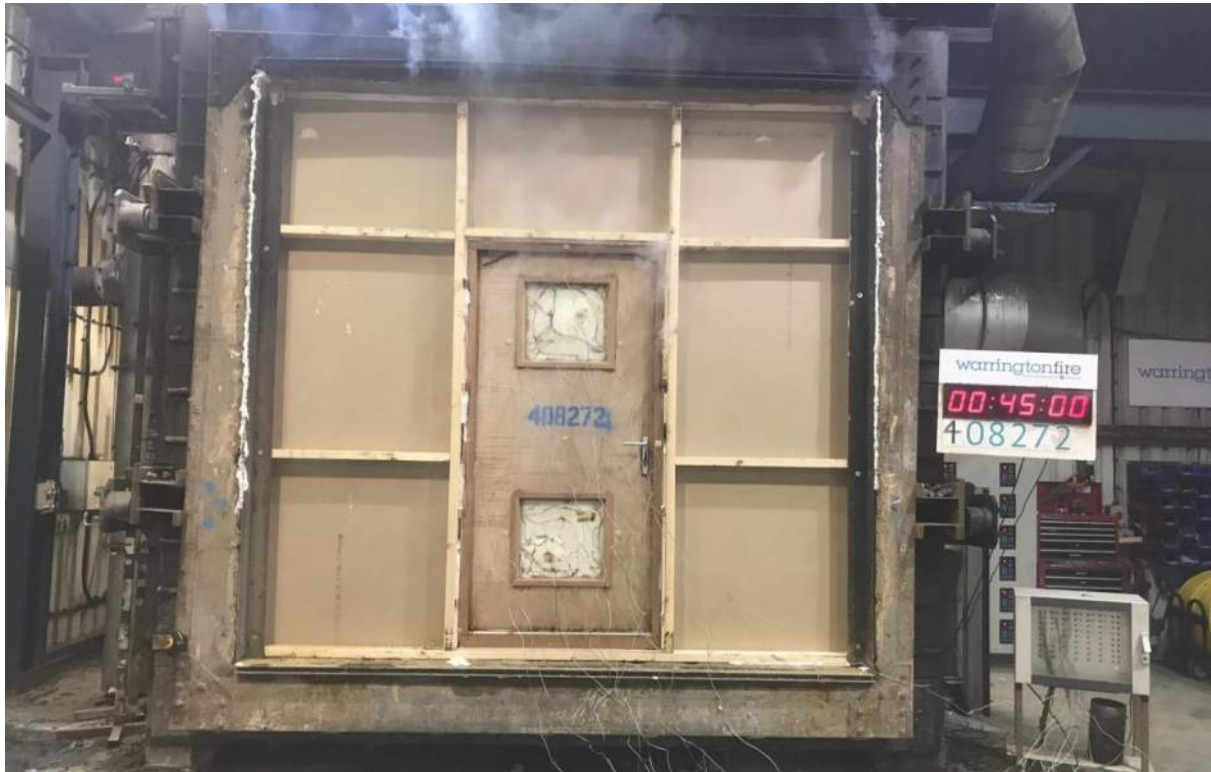
At 45 minutes

- 45:00 The graphite is oozing from the threshold.
- 51:00 There is an increase in smoke issuing from the top and bottom glazing.
- 55:00 There is an increase in smoke issuing and discolouration around the latch position.

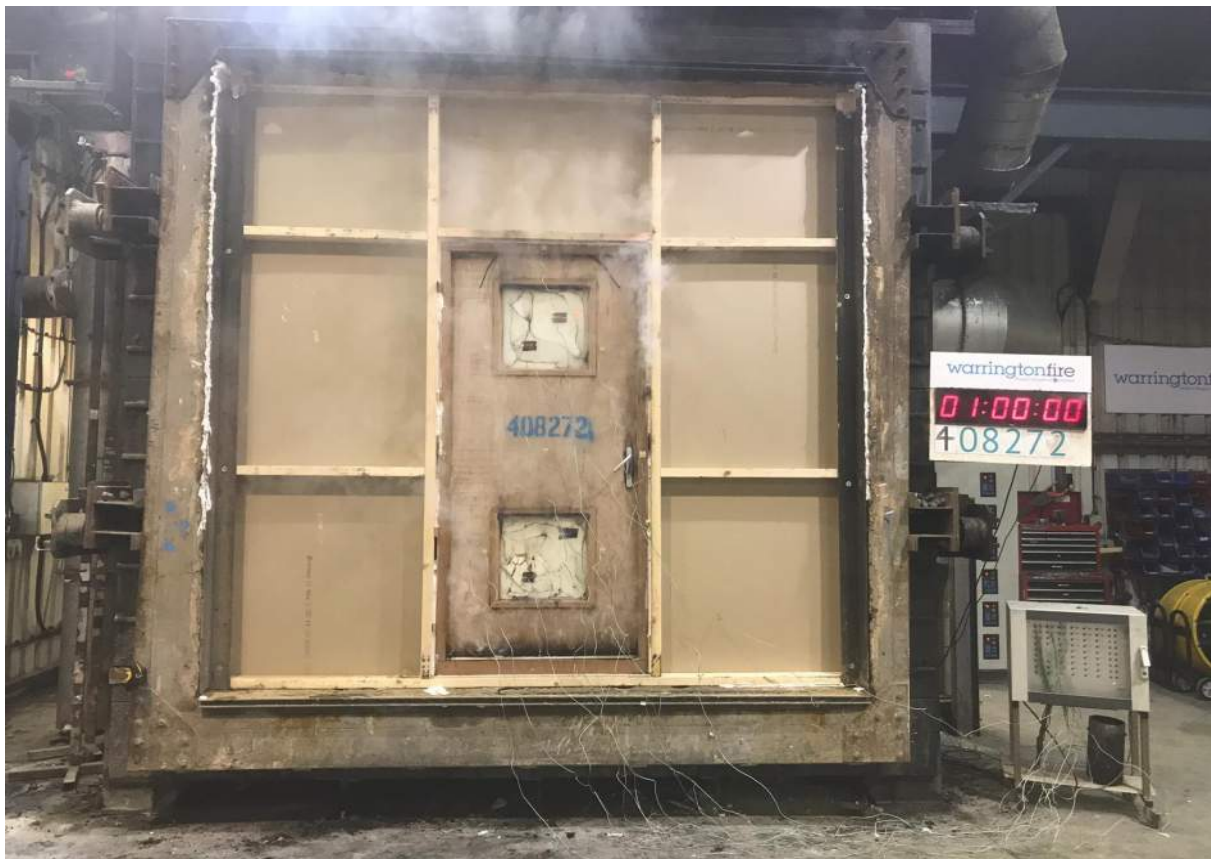
At 60 minutes

- 58:00 There is an increase in smoke issuing from the threshold.
- 62:20 The graphite is falling from the top of the top glazing bead and left of the bottom glazing bead.

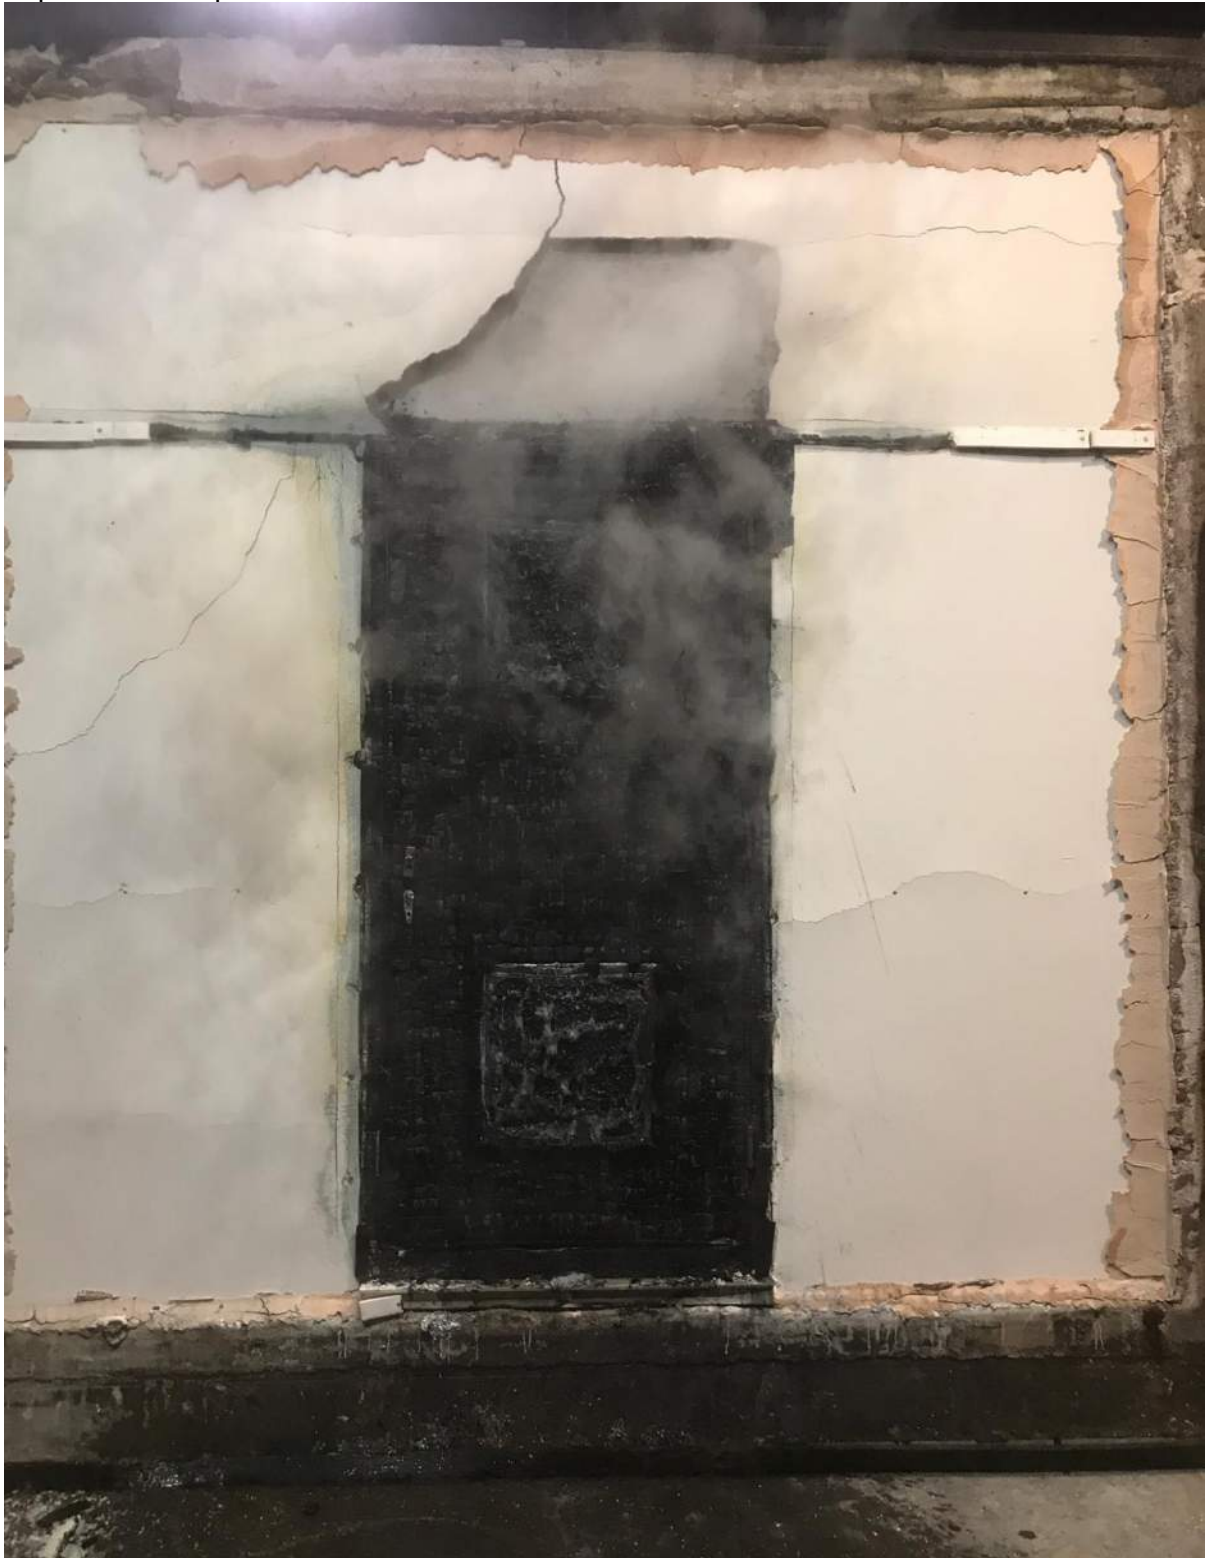
Exposed face – post test

- 70:50 A cotton pad integrity test was performed at the bottom closing corner which did not result in the ignition of the cotton pad.
- 71:10 There is continuous flaming at the bottom closing corner thereby constituting **integrity failure**.

- 72:00 There is continuous flaming at the bottom glazing thereby constituting **further integrity failure**.
- Test terminated
