The fire resistance performance of a single-leaf, single-acting doorset, when tested in accordance with BS 476: Part 20 and 22: 1987

403587 AR1

**Pacific Rim Wood Ltd**

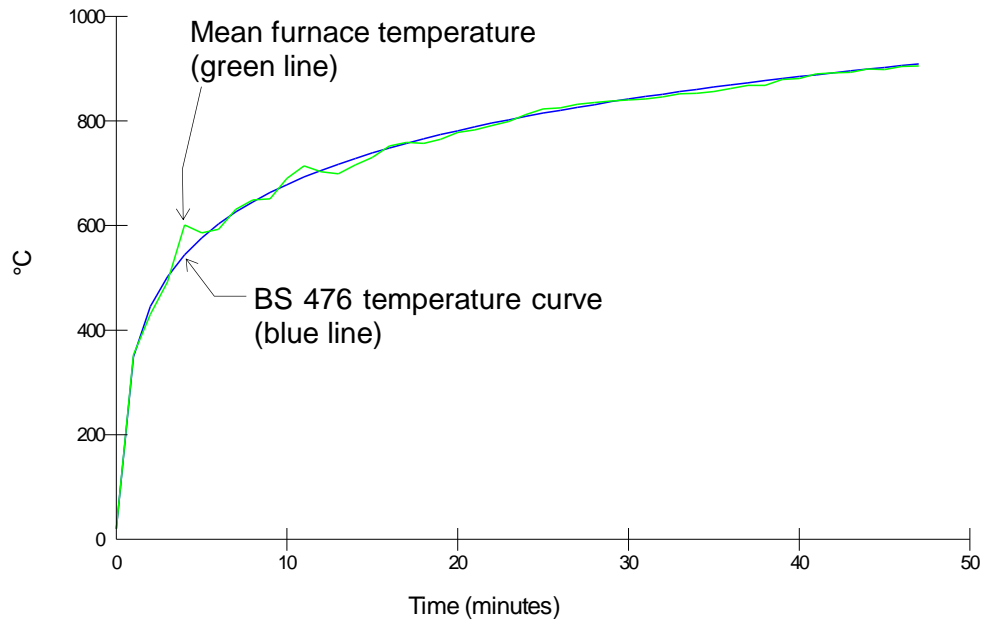
### 5.1 Furnace Temperature Curve

The furnace was controlled to follow the temperature/time relationship specified in BS 476: Part 20: 1987, using the average of nine thermocouples suitably distributed within the furnace. The temperatures recorded are shown graphically in Section 5.1.

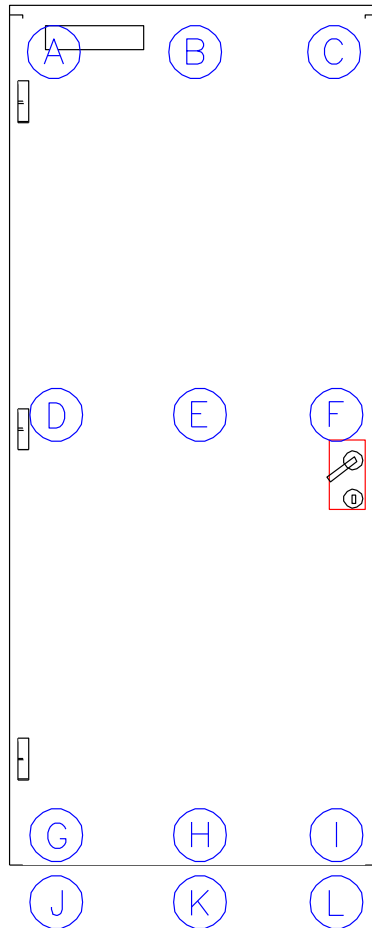
### 5.3 Door Distortion Data

The following tables show the distortion of the door in mm with an accuracy of  $\pm 1$ mm.

A positive measurement indicates distortion towards the furnace.

A negative measurement indicates distortion away from the furnace.

J, K and L give vertical movement of the door, a negative reading indicates that the door has dropped.

**Doorset - leaf (hung on the left and opening out away from the furnace)**

Time	A	B	C	D	E	F	G	H	I	J	K	L
10	2	3	3	0	2	3	0	-1	-2	0	0	0
20	3	3	6	0	-4	-2	-3	-2	0	0	0	-1
30	6	4	7	0	-9	-2	-1	-2	1	0	0	-1
40	5	3	9	-2	-21	-1	-3	-5	0	0	-1	-1

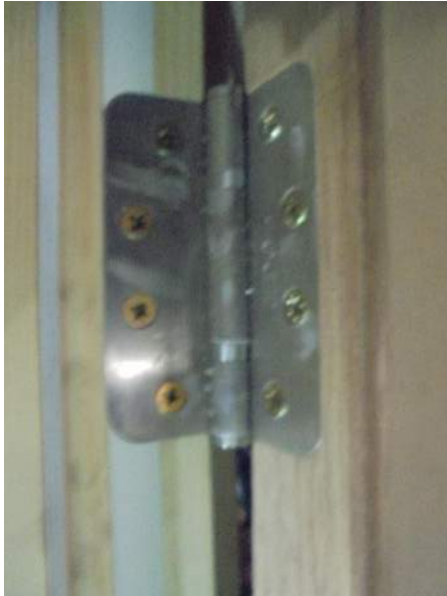
Intumescent interruptions by hardware

Around hinge blade

Make/type	Size (mm)	Location
Around hinges	Fully interrupted	-	Hinge blade fully interrupts seal in frame reveal
Under hinge blade	None fitted	-	-
Encasing lock/latch body	None fitted	-	-
Around latch keep	Fully interrupted	-	Latch keep fully interrupts seal in frame reveal
Under latch keeps	None fitted	-	-

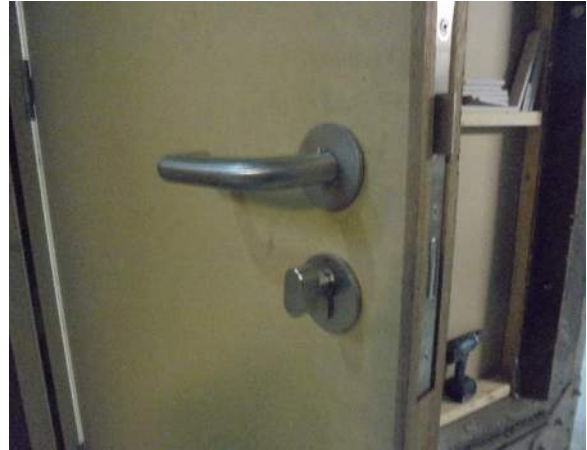
Around the latch

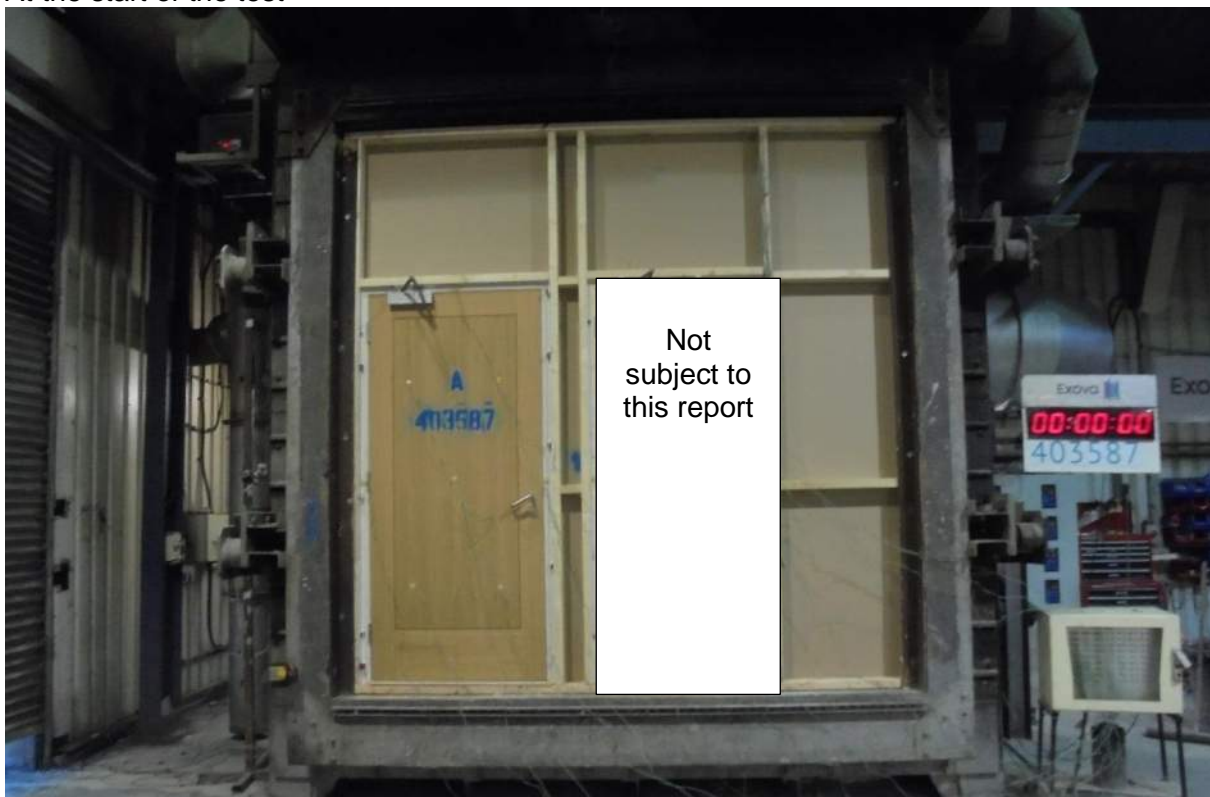
At the start of the test

<b>Time (minutes)</b>	<b>Comments</b>
00:00	Test started
02:30	There is smoke issuing at the top closing corner.
04:10	There is an increase in smoke issuing across the head.
05:30	There is smoke issuing at the top hinge position.
08:50	There is smoke issuing at the top hanging corner.
09:00	There is an increase in smoke issuing at the threshold.
10:00	There is an increase in smoke issuing at the hanging edge.
12:20	There is smoke issuing at the middle hinge position.
13:00	There is an increase in smoke issuing from the middle hinge position upwards on the hanging edge.
14:00	There is smoke issuing at the middle hinge position.
17:30	There is an increase in smoke issuing at the top hinge position and latch position.
22:00	There is discoloration at the top hinge position.
47.00	Test terminated

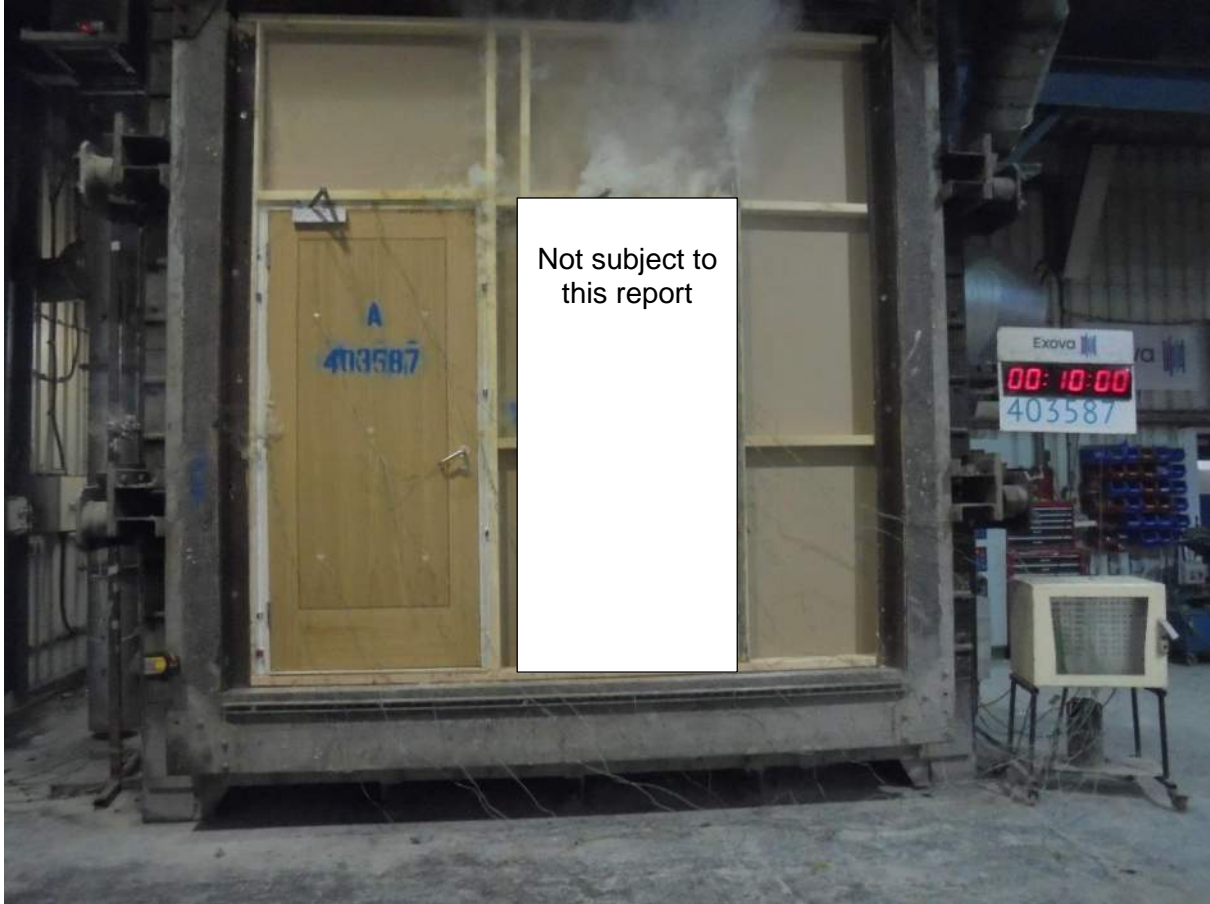
At 10 minutes

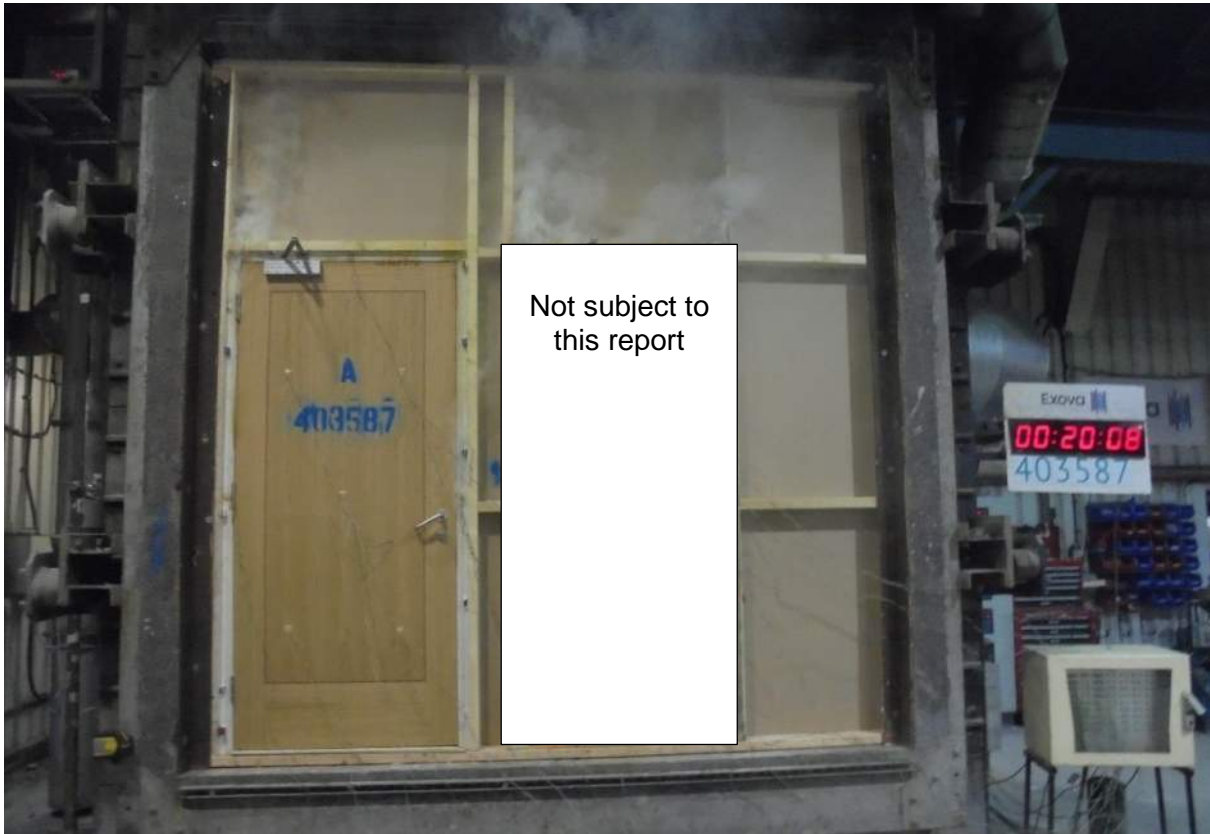
After 20 minutes

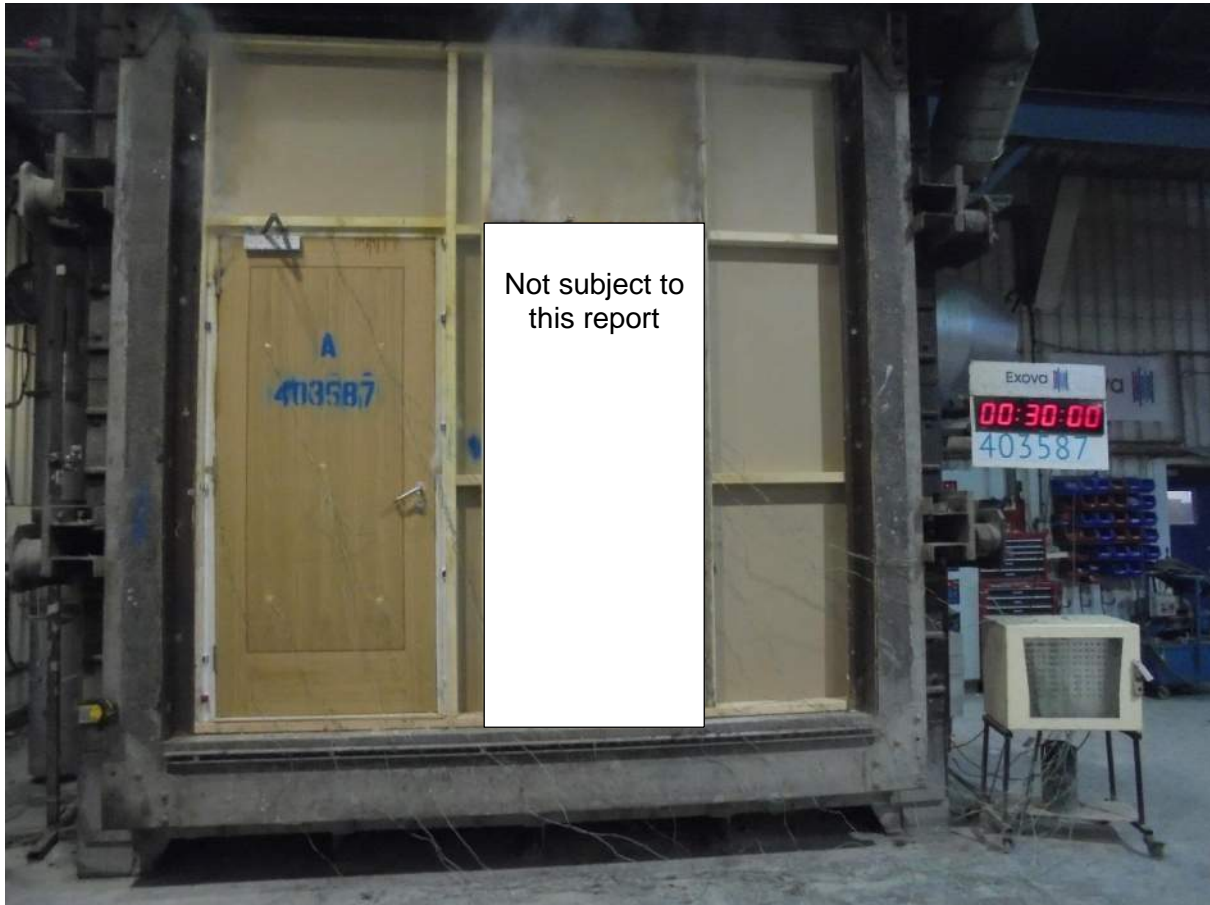
At 30 minutes

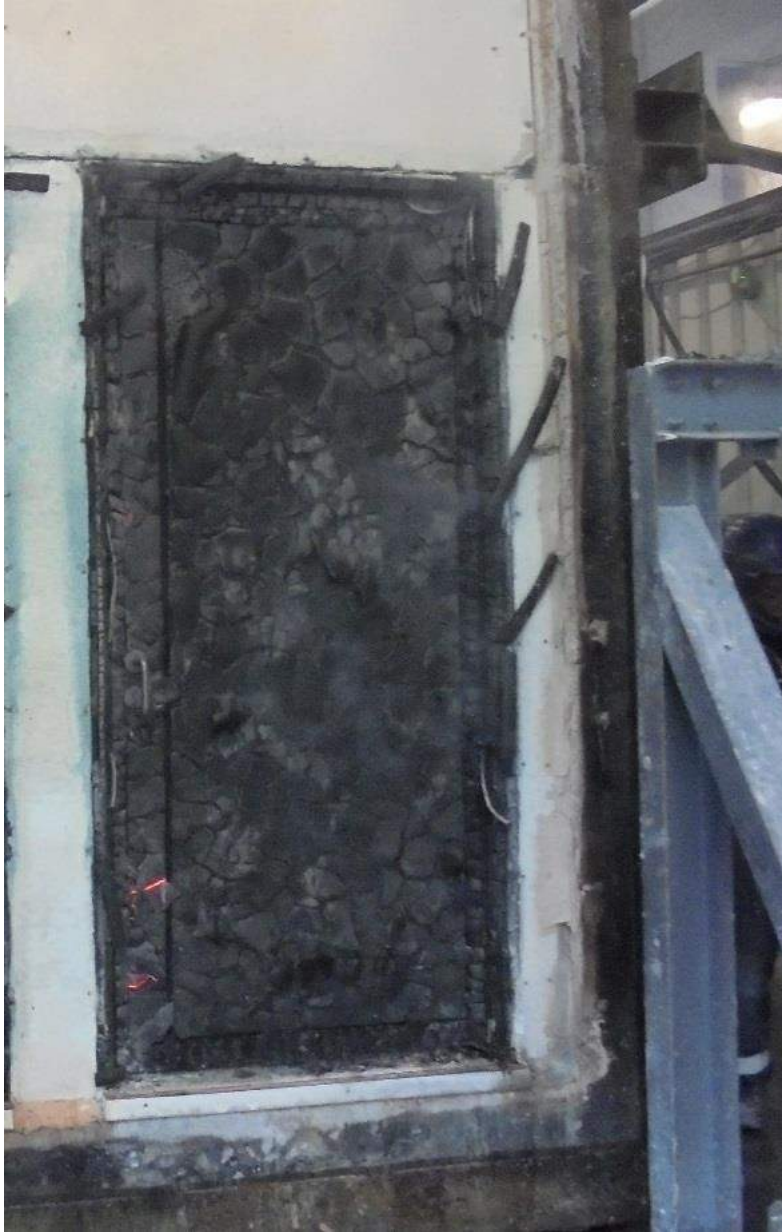
Exposed face – post test
